HEYNE TILLET STEEL

Job Name
One Berkeley Street

Drawing Title
Typical Drainage Details

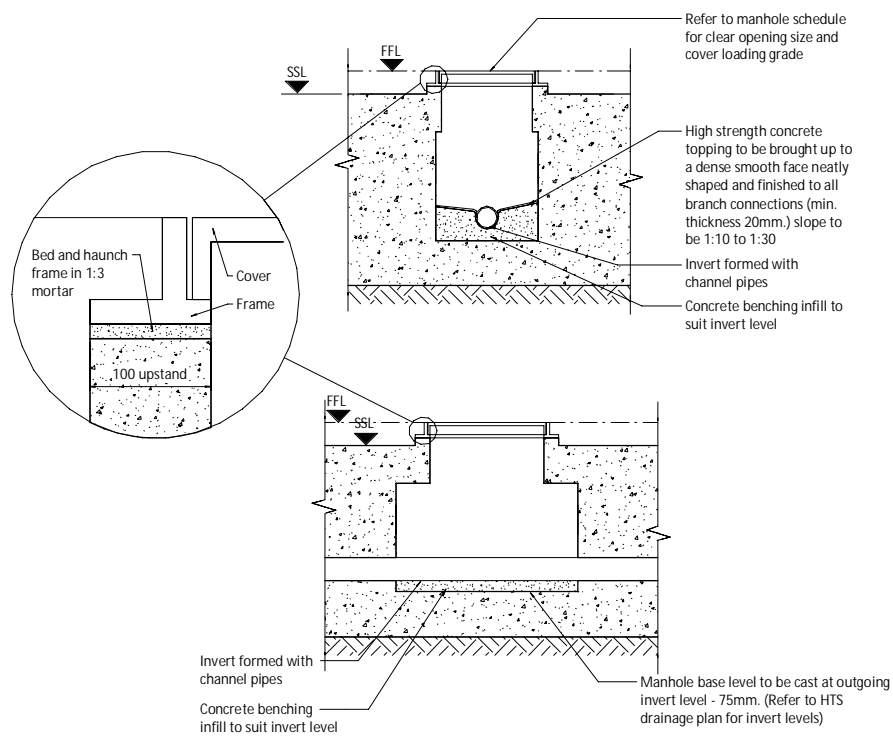
Typical In situ Manhole Detail

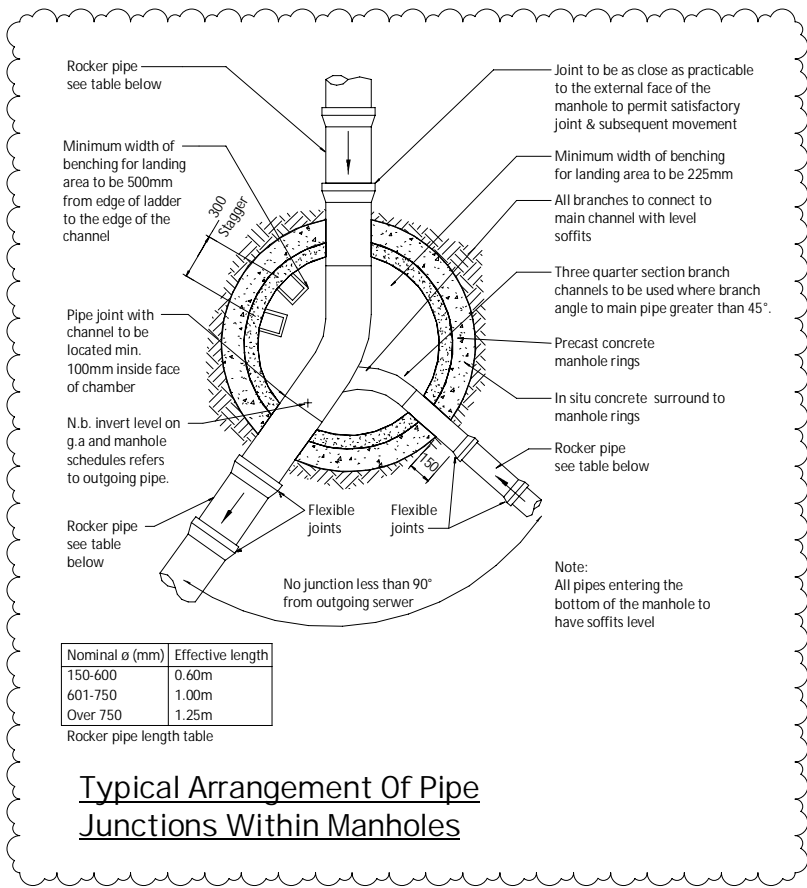
Typical Arrangement Of Pipe Junctions Within Manholes

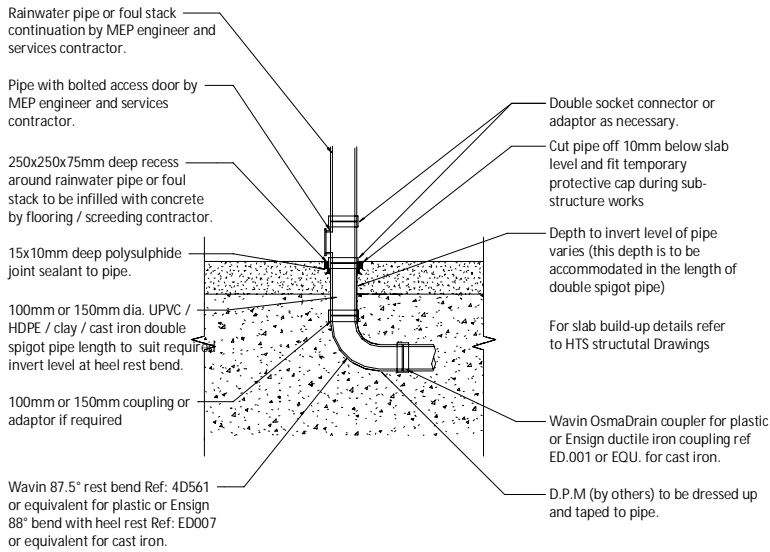
Typical Slab Penetration detail

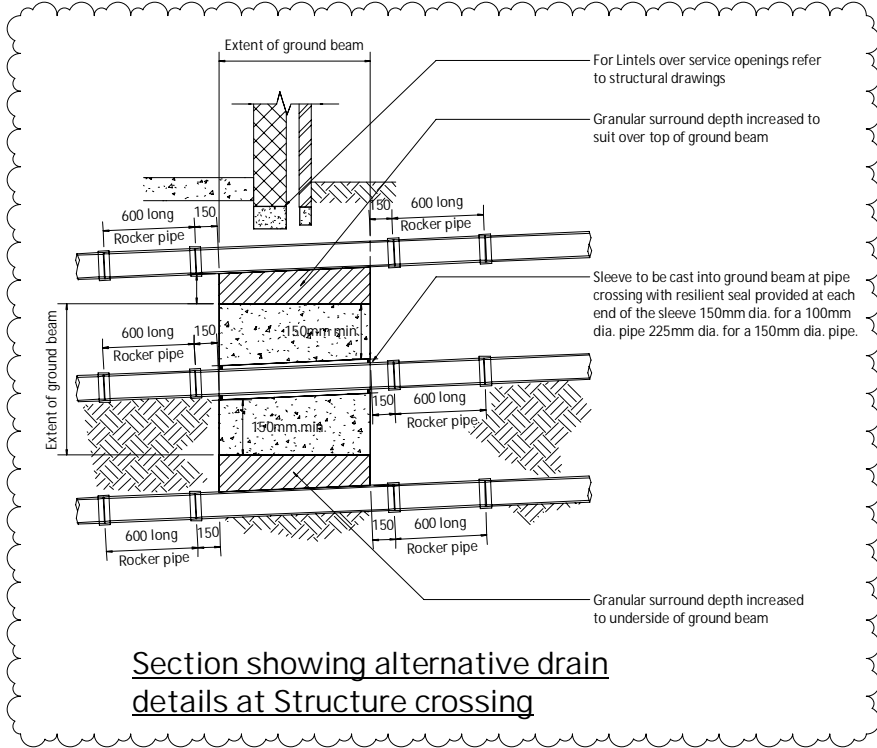
Section showing alternative drain details at Structure crossing

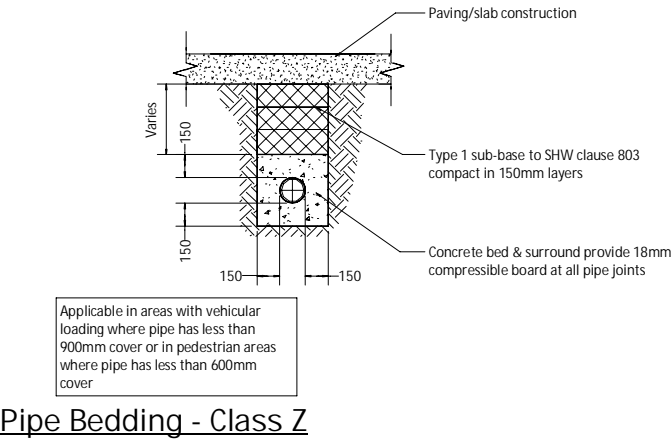
Pipe Bedding - Class Z

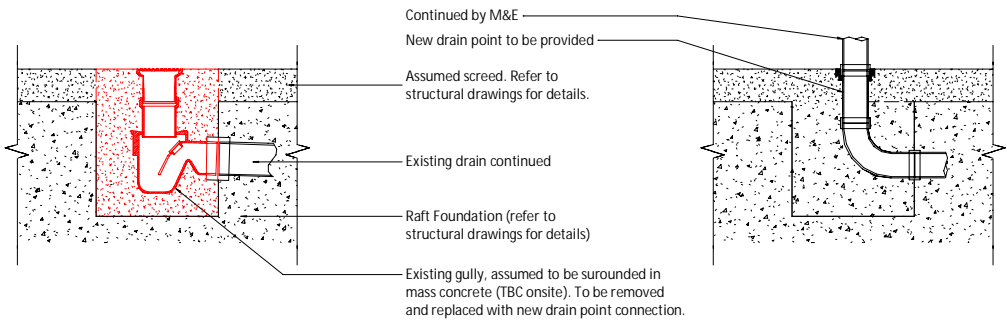
Typical Detail Showing a Floor Gully Replaced with a Drain Point
